Pineries Open Space Tier One Trail Corridor Clearance Final Project Report

November 3, 2016

Report Prepared by: Andy Riter, RMFI Program Coordinator

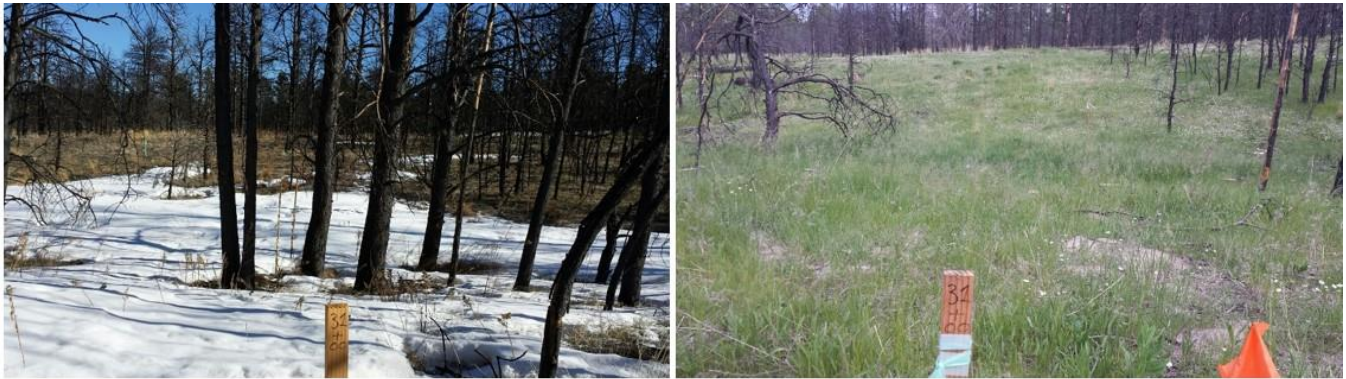
Figure 2. Before and after photos at task 2, trail corridor clearance and hazard tree removal along a future tier 1 trail route. A corridor 12 feet wide was cleared of trees and shrubs and hazard trees were removed out to a distance of 60 feet on each side. The stake indicates a distance of 3,100 feet from the start of this segment of alignment.

to directly south of the northwest pond. The purpose of the alternate segments was to provide options for trail alignment remaining outside of the 500-foot buffer from neighboring properties to the west. Certain segments of primary alignment were marked just within the 500-foot buffer to route through green (unburned) trees, to pass on the edge of a meadow, and to avoid passing through additional large patches of severely-burned standing (hazard) trees. Community Services Department staff invited neighboring residents to review both options for alignment in an early May visit following RMFI's corridor clearance. Along the primary and alternate alignment, RMFI felled and disposed of approximately 393 trees, almost all of these hazard trees. GPS track files for the primary and alternate alignments were provided to the County staff. Photos in Figures 2 through 5 show examples of this work.

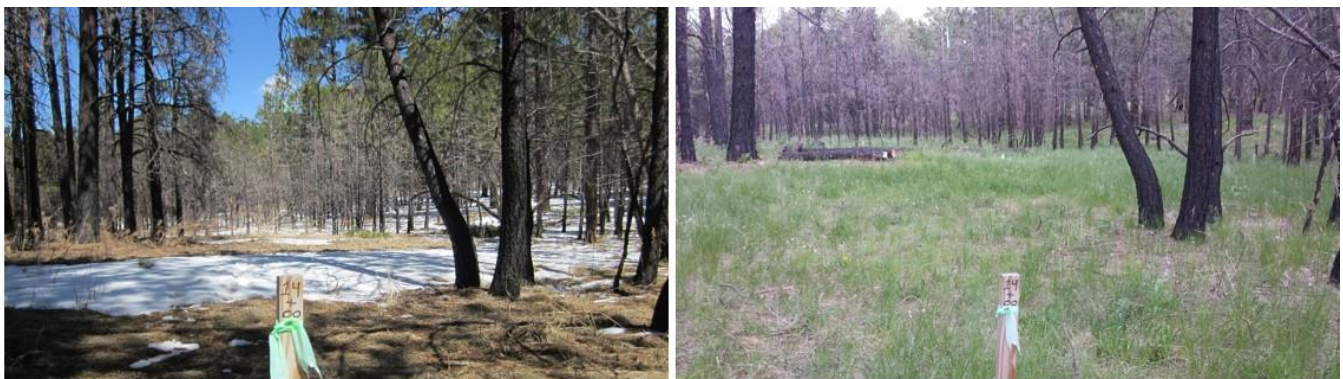
Figure 3. Before and after photos at task 2. Trail alignment sought to preserve as many live trees as possible. The trail alignment bends to the right, around live trees, in the right foreground of this photo.

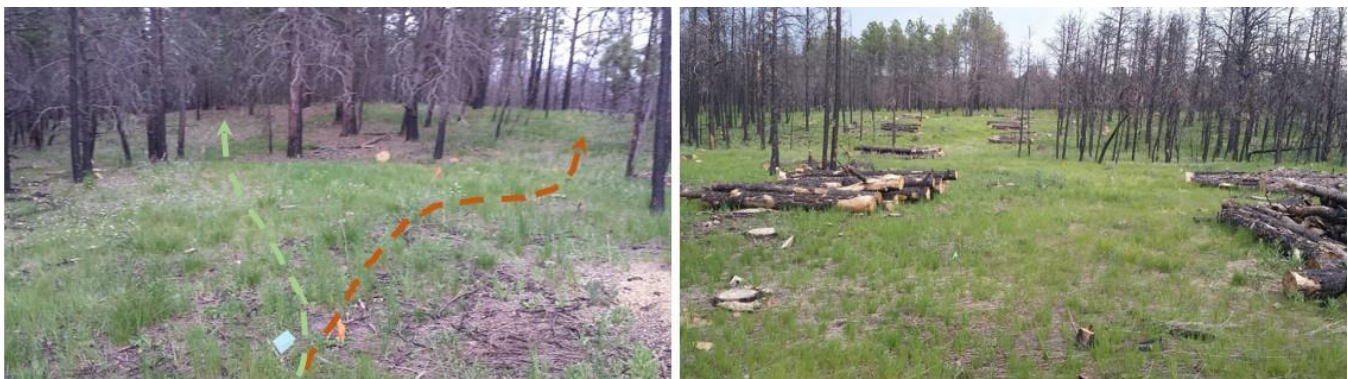
Figure 4. The left photo depicts one of several segments where primary (green) and alternate (orange) alignment options were marked, usually to give options to stay in “green” trees or through dead trees and outside of the 500-foot buffer of private properties to the west. The right photo shows one of many segments where the alignment had to transit a severely burnt area with a heavy hazard tree removal requirement. Volunteers were indispensable for scattering branches (slash).

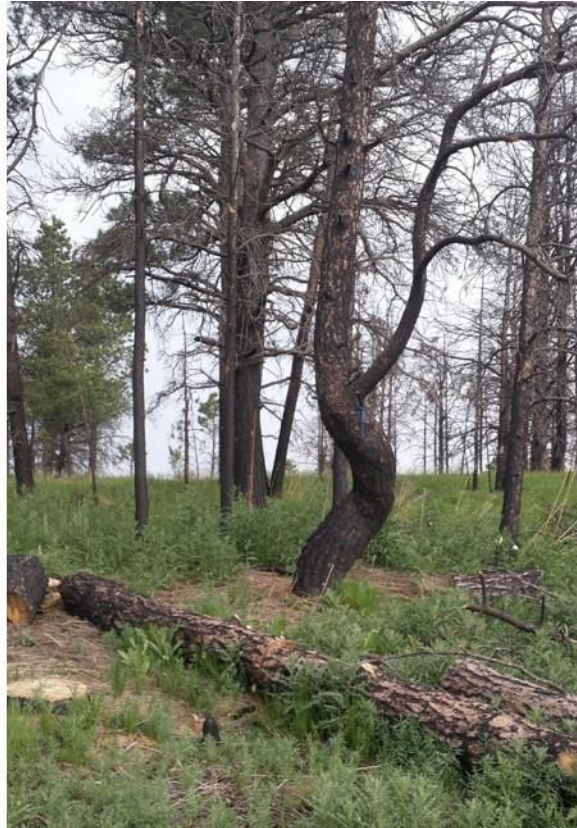
Figure 5. Photo of a possible Culturally Modified Tree (CMT) or “Ute Tree” at the north end of the alignment (at stake 43) with a hazard tree felled in the foreground. Particular care was taken to report and to avoid impacting such trees and the inventory of rare plants on the property. The alignment passes approximately 15 yards west of this tree, which was killed in the fire.

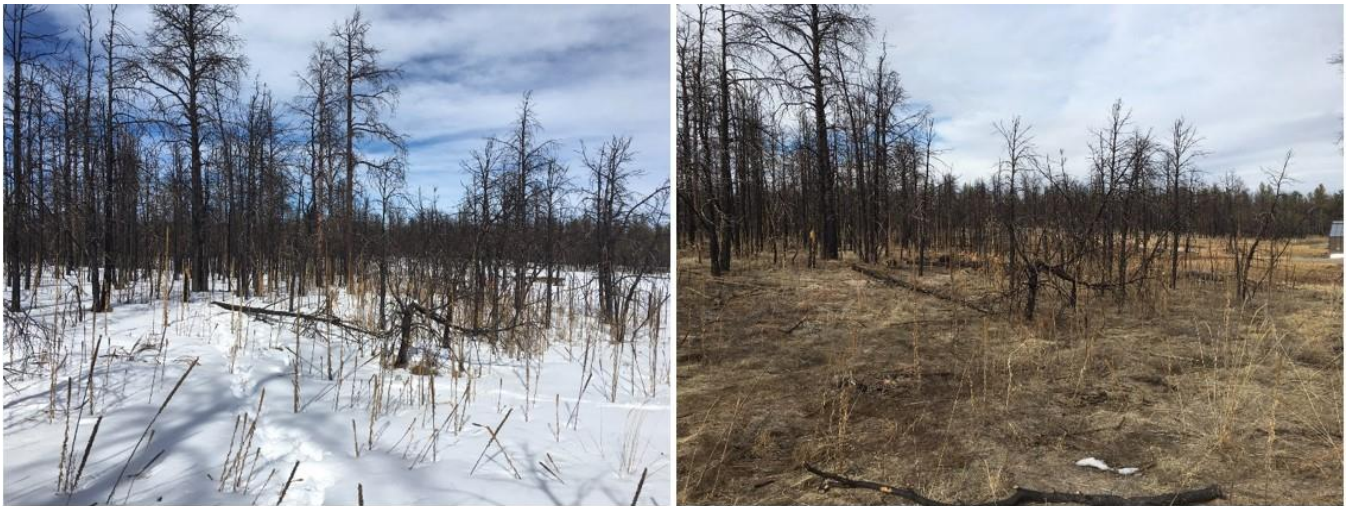
Figure 6. Before and after photos at task 4, hazard tree removal on Pineries property along private property fencing. Dead, standing trees meeting hazard tree criteria were the only trees felled and processed with slash dispersed. Smaller trees were left and efforts made to avoid clear-cutting an un-natural even corridor.

Task 4. RMFI staff designated and felled approximately 217 hazard trees from within 60 feet of private residential property and fencing along the Blue Spruce Lane neighborhood. Slash from the processed trees was dispersed on the POS property and remaining logs were stacked for future use by County staff. Many of the hazard trees were large, mature ponderosas, and several had leans toward the private property, necessitating special techniques to assure felling onto POS property. In only one case did the top 5 feet of a hazard tree fall onto a neighboring property, striking a wire fence and causing slight stretching of the fence wire. RMFI settled the cost for repair directly with the neighbor, who was understanding and happy that the tree removal was conducted. Figures 6 and 7 show examples of this work.

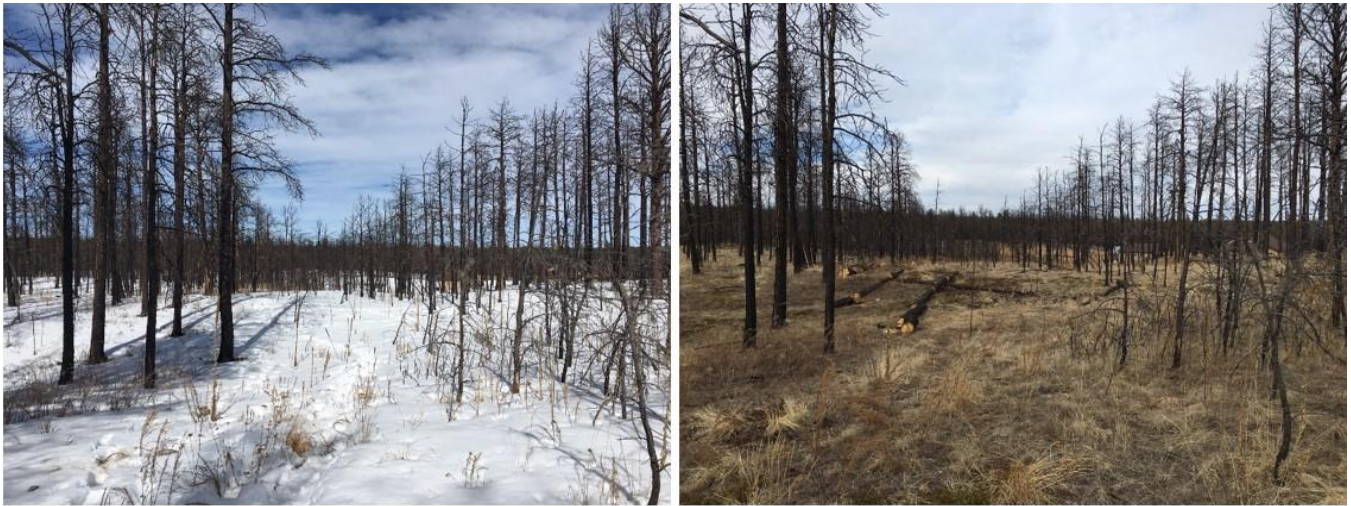
Figure 7. Before and after photos at task 4. Considerable pre-cautions were taken to prevent tree strikes across property lines as all felling was of hazard trees within 60 feet. Mature, dead trees on the right of the photos are within private property adjoining the Pineries property.
